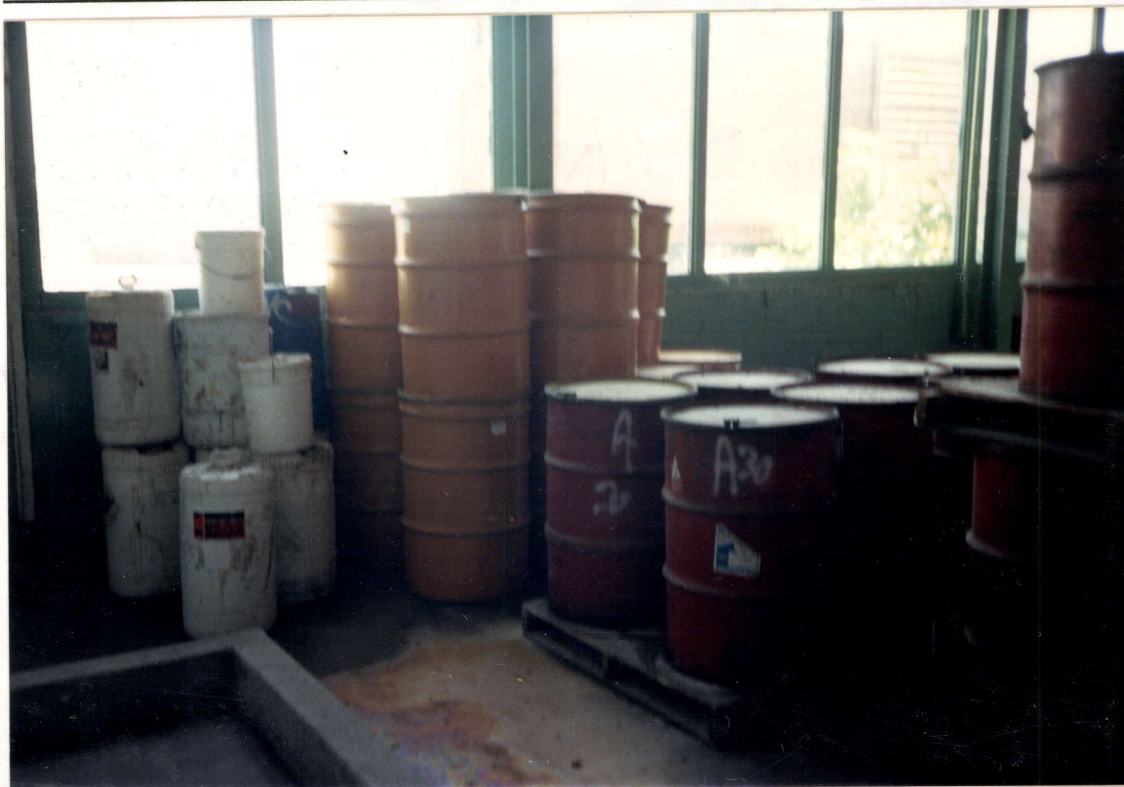
Film Roll No.: 1 Date: 6/19/90 Time: 1010
 Exposure No.: 12 Photographer: JPN
 VSI Observations: Storage of nonregulated (nonhazardous) waste; empty and reconditioned drums in Bldg. D, north portion. View - NE

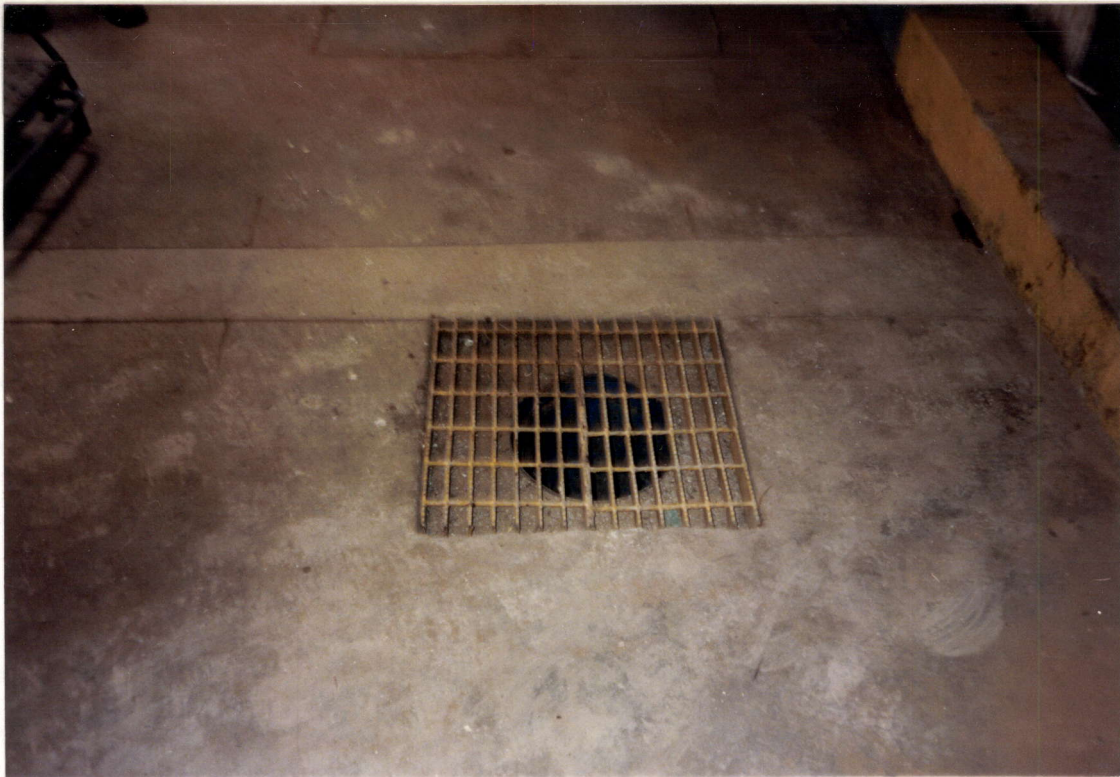
Film Roll No.: 1 Date: 6/19/90 Time: 1012
 Exposure No.: 13 Photographer: JPN
 VSI Observations: Sump in elevated tank area, west end of Bldg. D.
 View - E

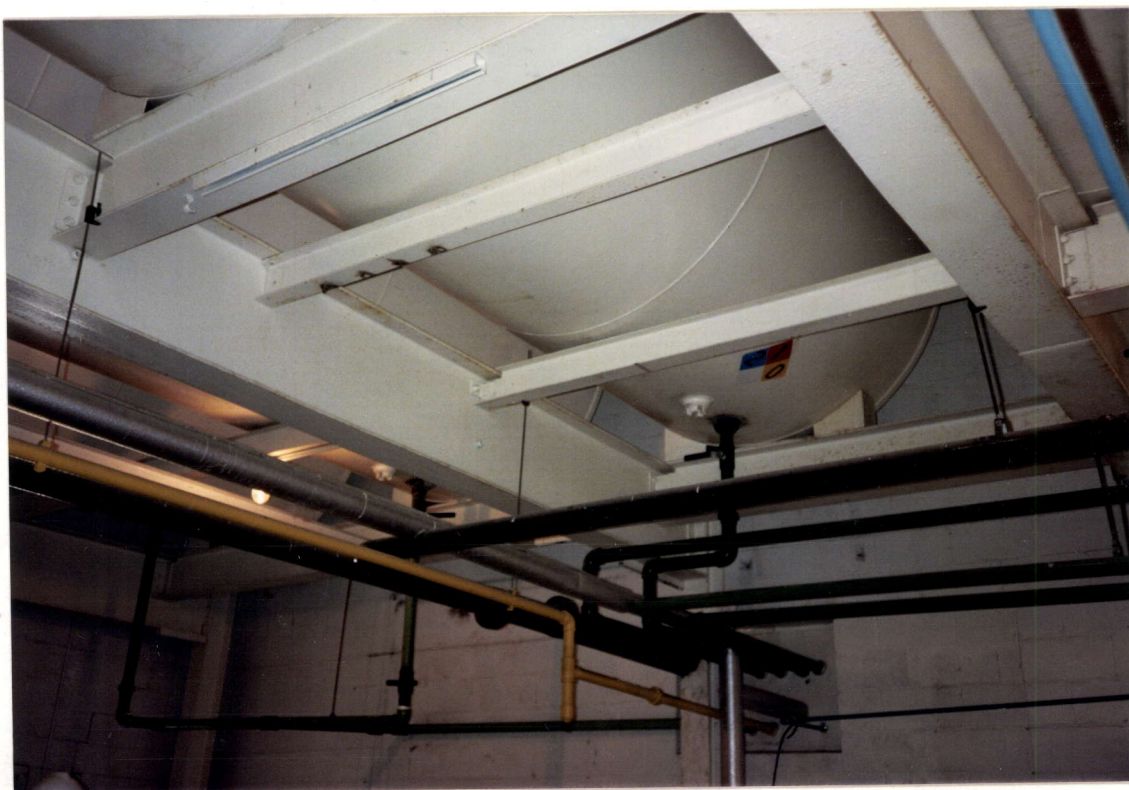
Film Roll No.: 1 Date: 6/19/90 Time: 1015
 Exposure No.: 14 Photographer: JPN
 VSI Observations: Elevated storage tanks in Bldg. D. View - SW

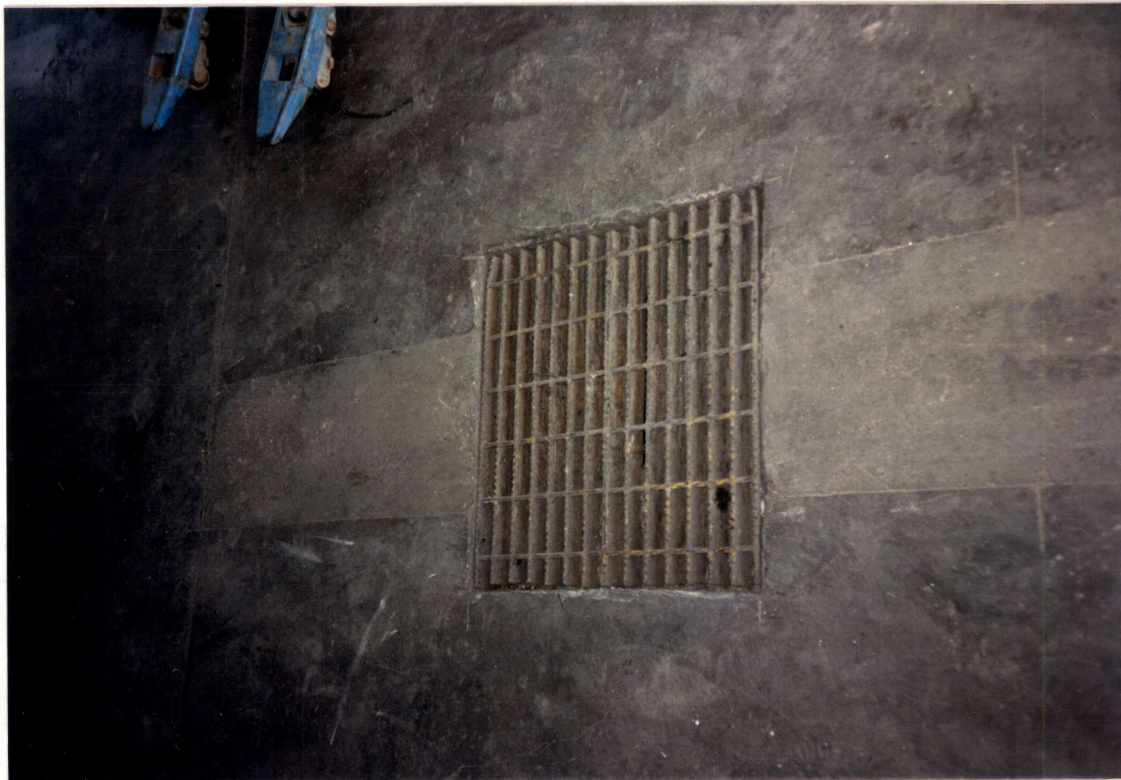
Film Roll No.: 1 Date: 6/19/90 Time: 1020
Exposure No.: 15 Photographer: JPN
VSI Observations: Sump in sparging area, Bldg. D. View - E

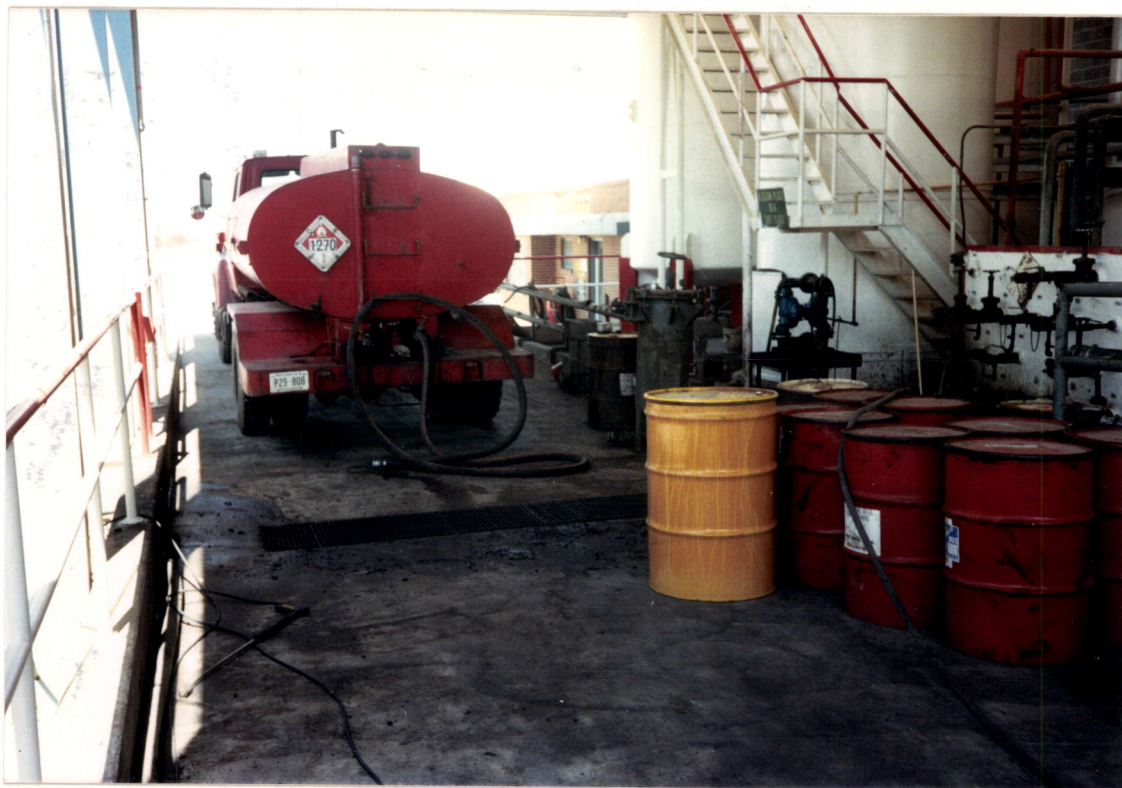
Film Roll No.: 1 Date: 6/19/90 Time: 1025
Exposure No.: 16 Photographer: JPN
VSI Observations: Trench drain sump in truck unloading bay, Process Area. View - W

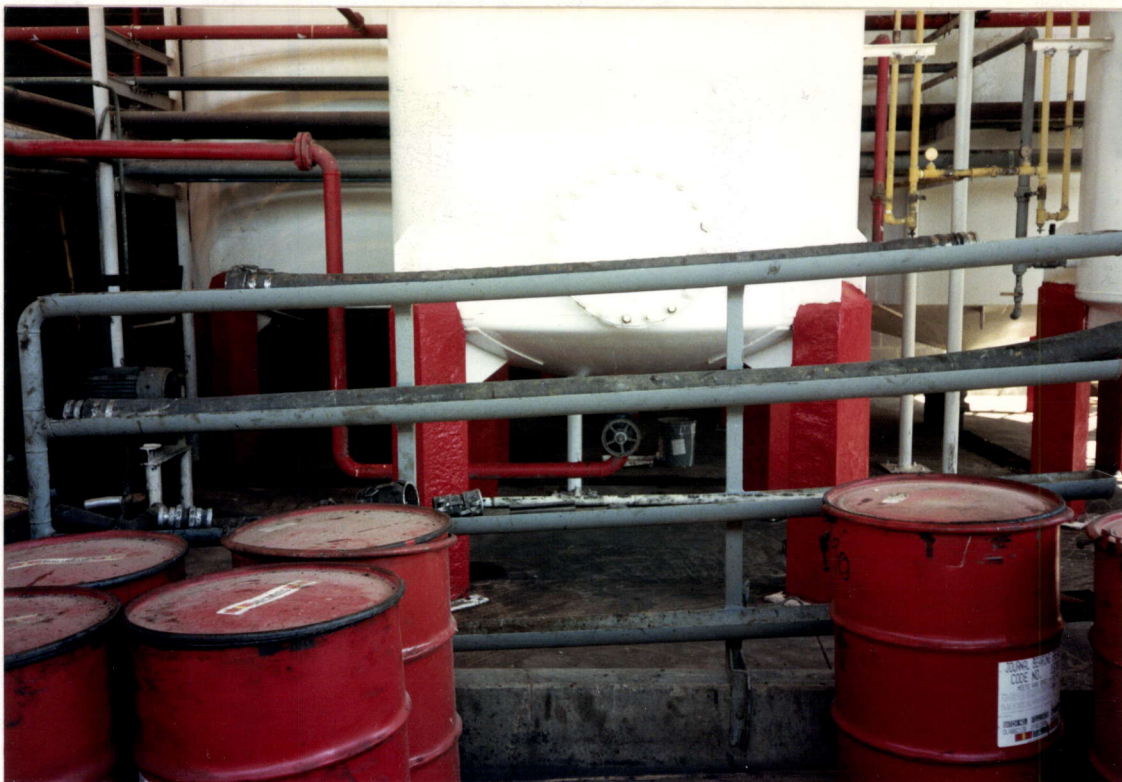
Film Roll No.: 1 Date: 6/19/90 Time: 1025
 Exposure No.: 17 Photographer: JPN
 VSI Observations: Storage tanks for flammable wastes, Process Area.
 View - N

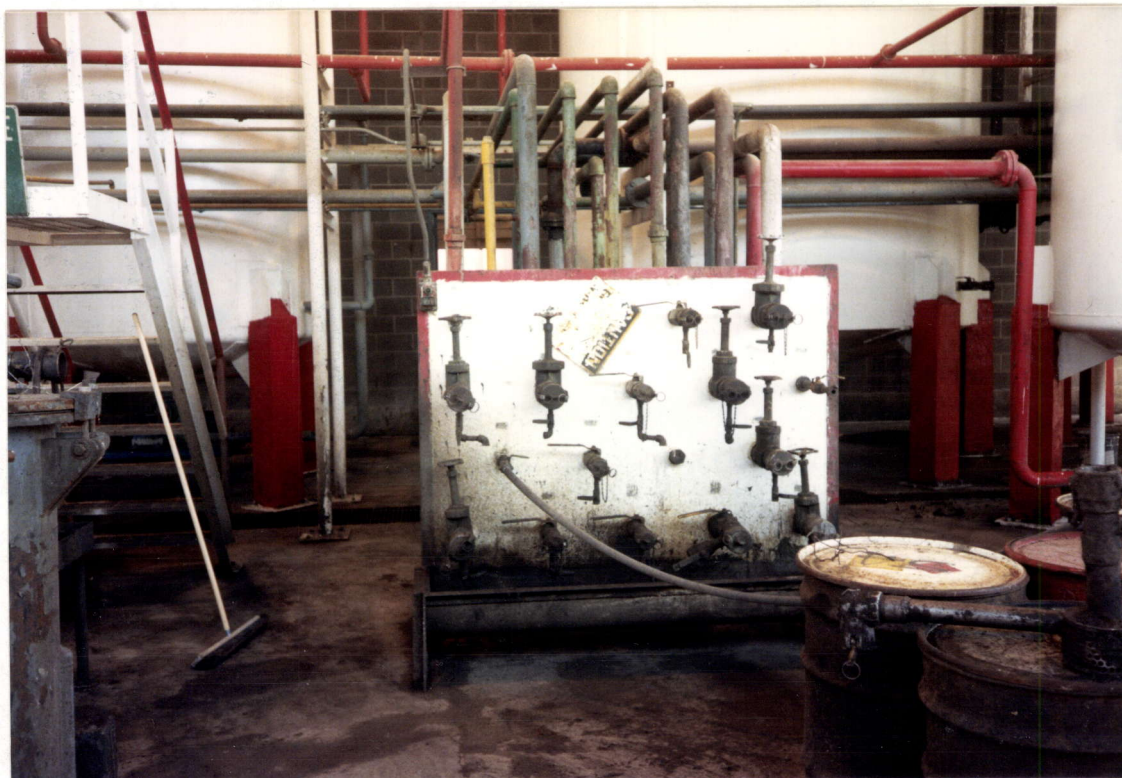
Film Roll No.: 1 Date: 6/19/90 Time: 1025
 Exposure No.: 18 Photographer: JPN
 VSI Observations: Manifold for tanker truck loading/unloading to Process
Area. View - N

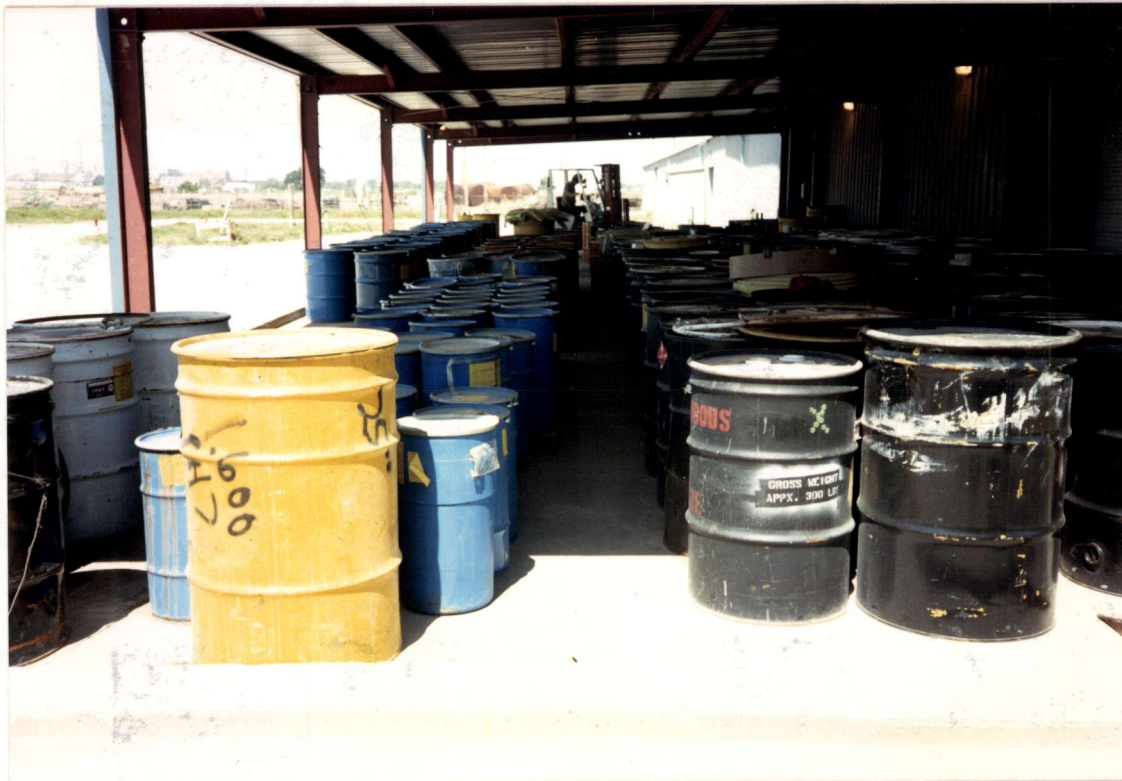
Film Roll No.: 1 Date: 6/19/90 Time: 1030
 Exposure No.: 19 Photographer: JPN
 VSI Observations: Drum staging area south side of Bldg. C. View - W

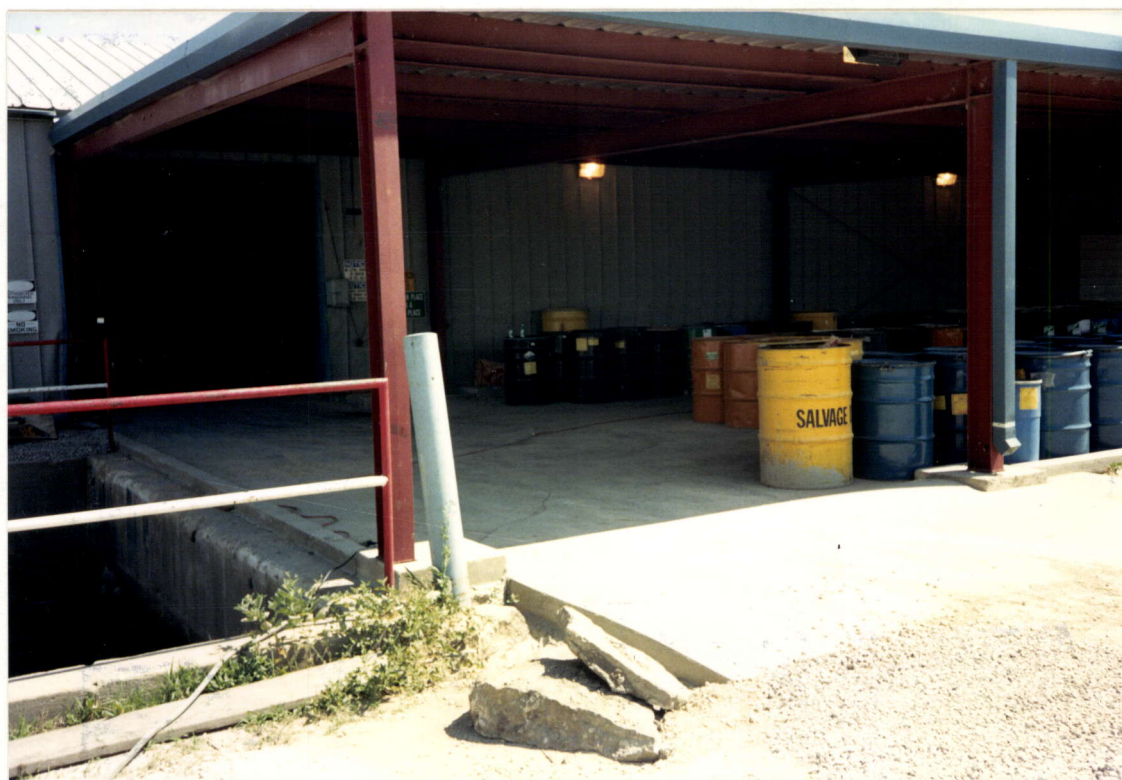
Film Roll No.: 1 Date: 6/19/90 Time: 1030
 Exposure No.: 20 Photographer: JPN
 VSI Observations: South central bay, Bldg. C. View - N

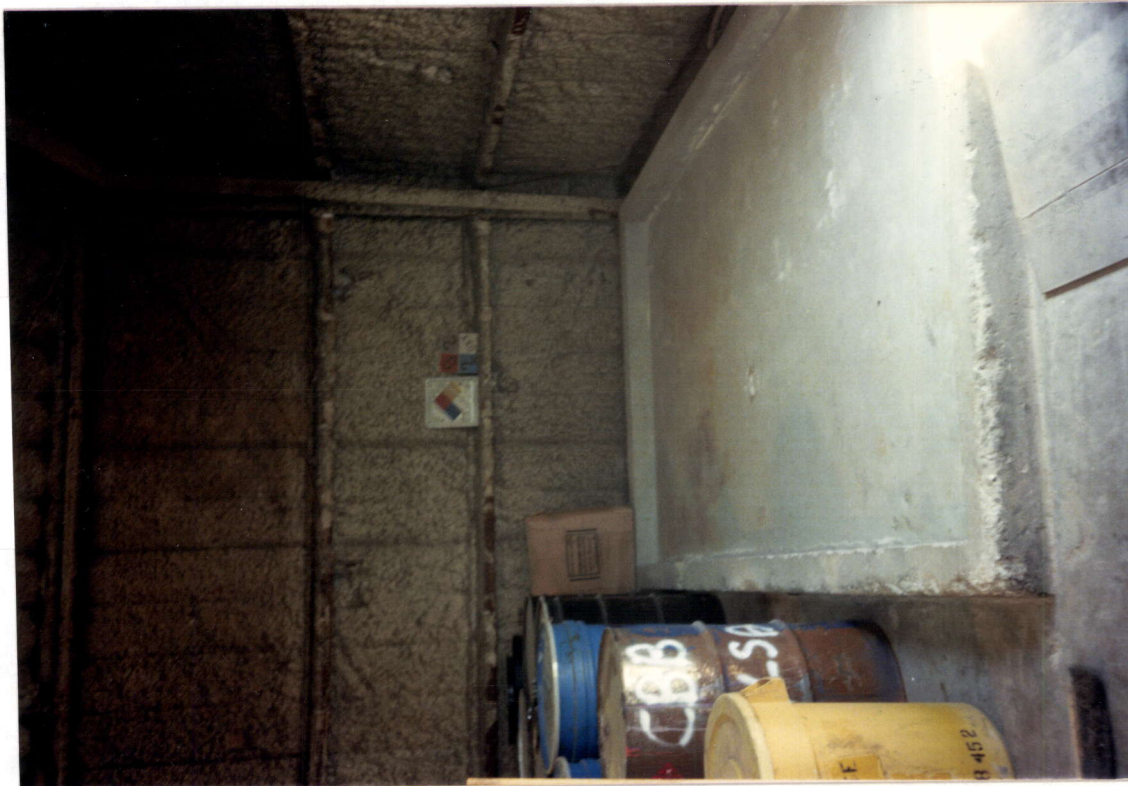
Film Roll No.: 1 Date: 6/19/90 Time: 1040
Exposure No.: 21 Photographer: JPN
VSI Observations: Diked incompatible waste storage area, northeast
corner of Bldg. C. View - N

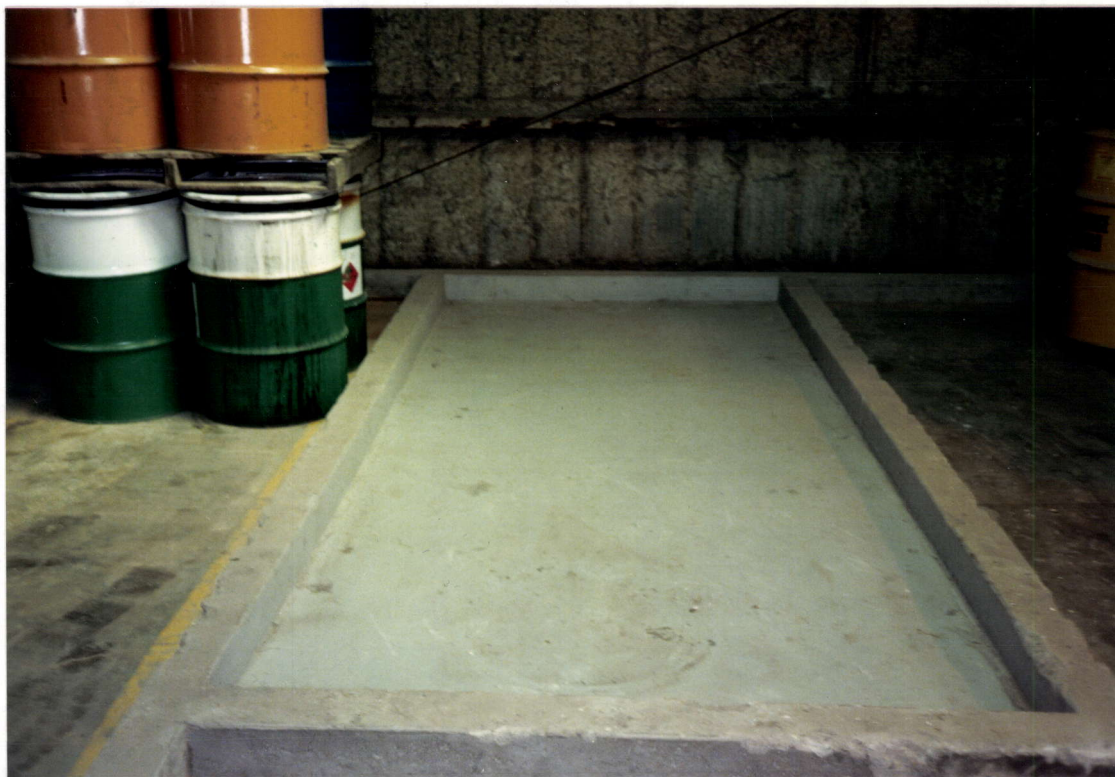
Film Roll No.: 1 Date: 6/19/90 Time: 1040
Exposure No.: 22 Photographer: JPN
VSI Observations: Diked incompatible waste storage area, northcentral
portion of Bldg. C. View - N

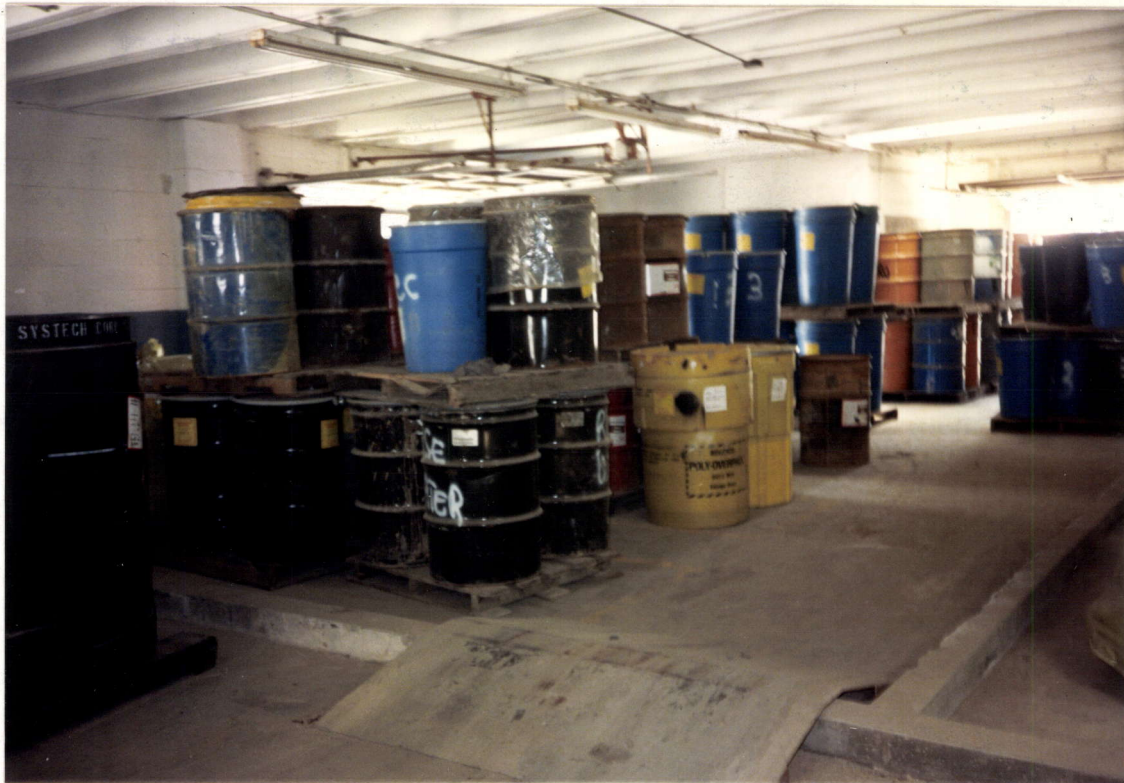
Film Roll No.: 1 Date: 6/19/90 Time: 1042
 Exposure No.: 23 Photographer: JPN
 VSI Observations: Incompatible waste storage area, west end of Bldg. C -
caustic corrosives. View - SW

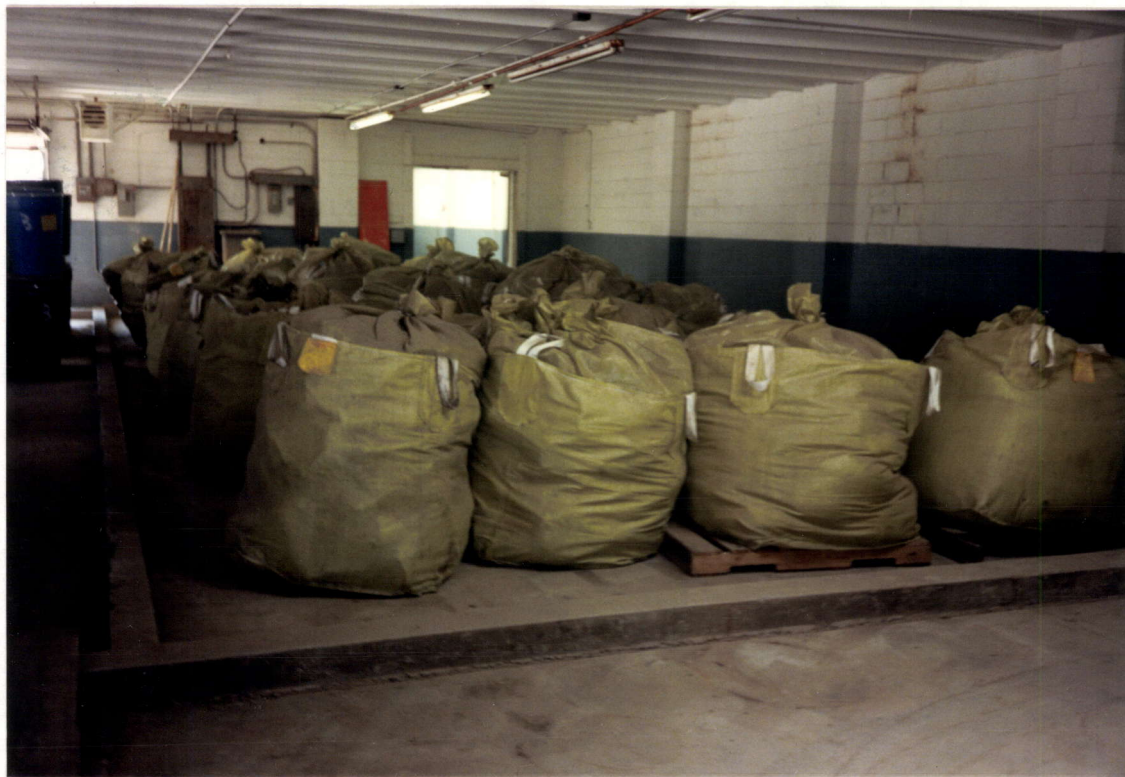
Film Roll No.: 1 Date: 6/19/90 Time: 1042
 Exposure No.: 24 Photographer: JPN
 VSI Observations: Incompatible waste storage area, West end of Bldg. C -
acid corrosives. View - NW

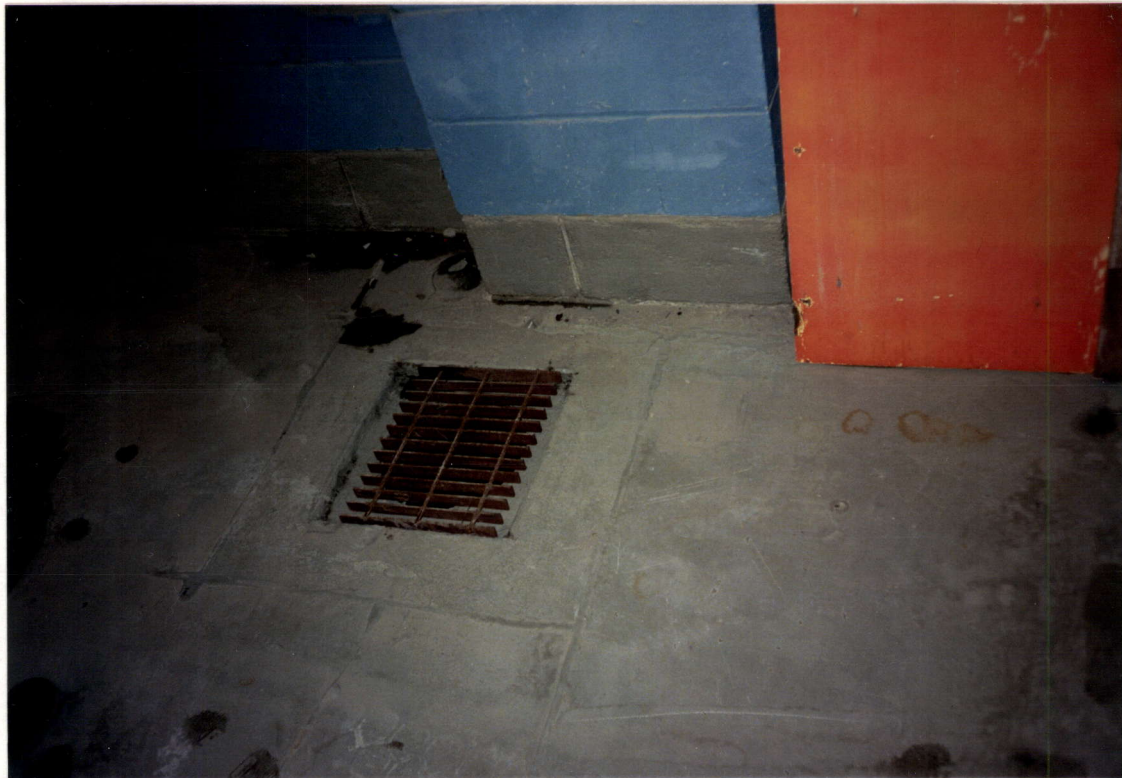
Film Roll No.: 1 Date: 6/19/90 Time: 1115
 Exposure No.: 25 Photographer: JPN
 VSI Observations: Blind sump in Bldg. B. View - E

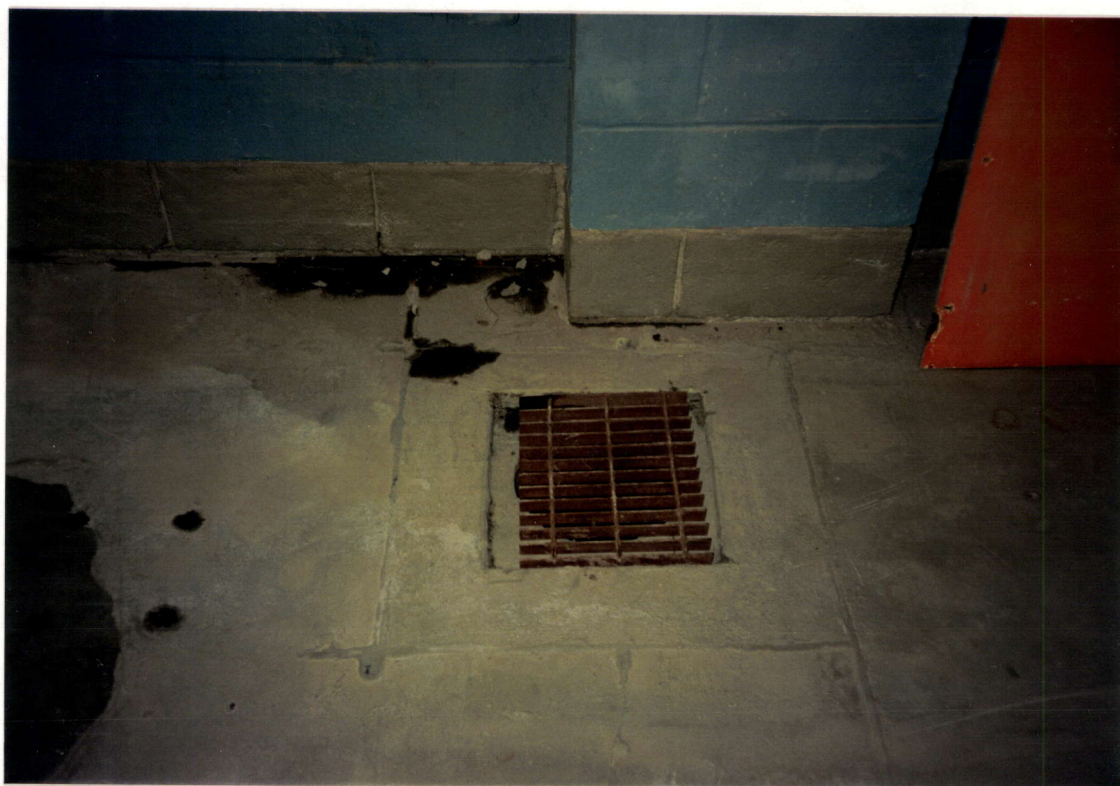
Film Roll No.: 2 Date: 6/19/90 Time: _____
 Exposure No.: 1 Photographer: JPN
 VSI Observations: Blind sump in Bldg. B (duplicate photo). View - E

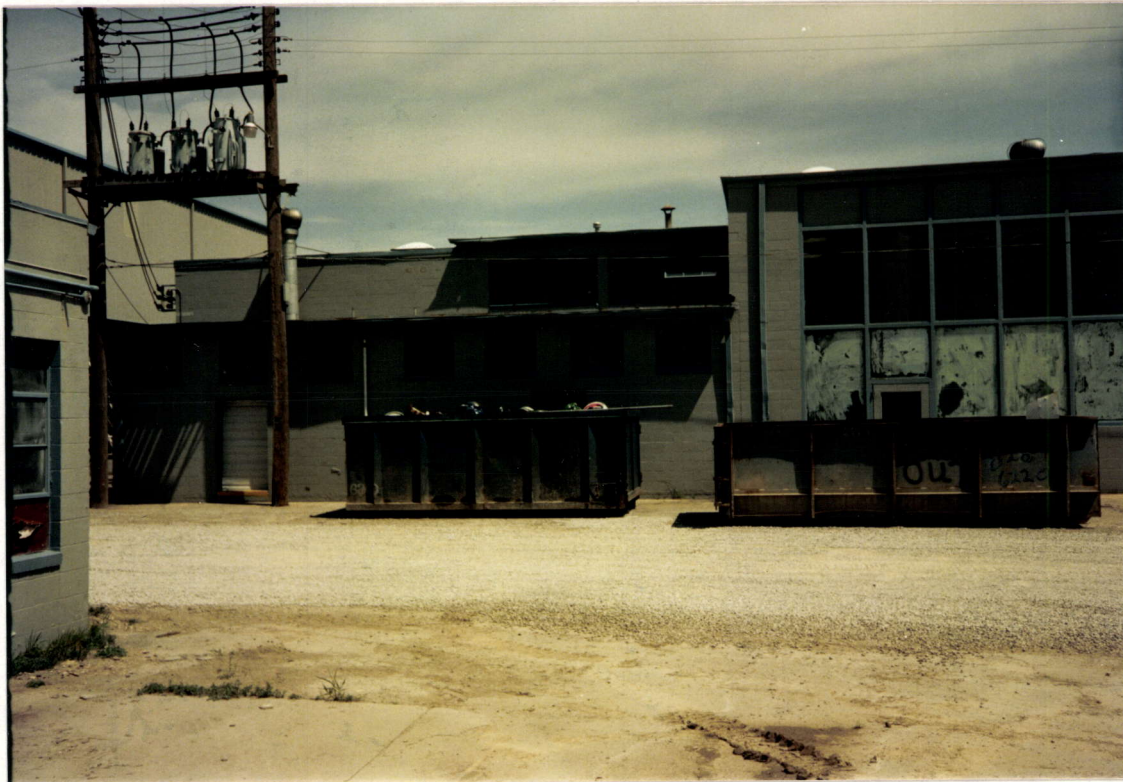
Film Roll No.: 2 Date: 6/19/90 Time: 1120
 Exposure No.: 2 Photographer: JPN
 VSI Observations: Two roll-off boxes south of Bldg. D, crushed drum
storage. View - N

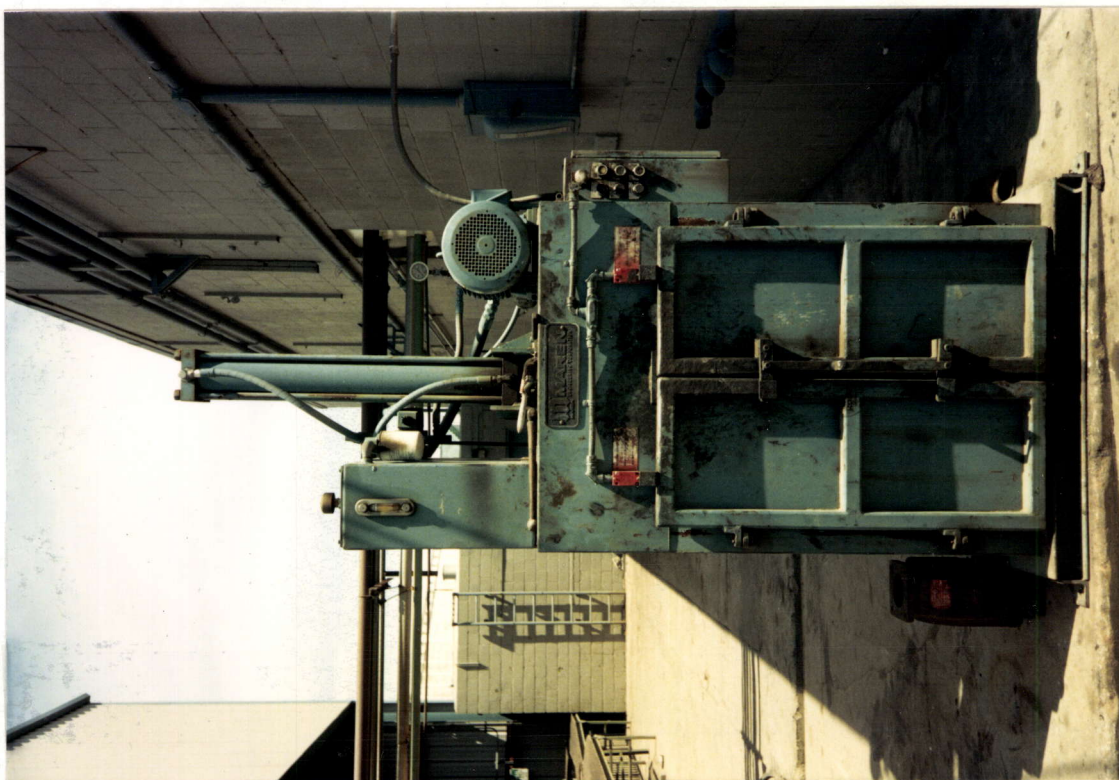
Film Roll No.: 2 Date: 6/19/90 Time: 1125
 Exposure No.: 3 Photographer: JPN
 VSI Observations: Drum crusher between Process Area and Bldg. D.
View - N

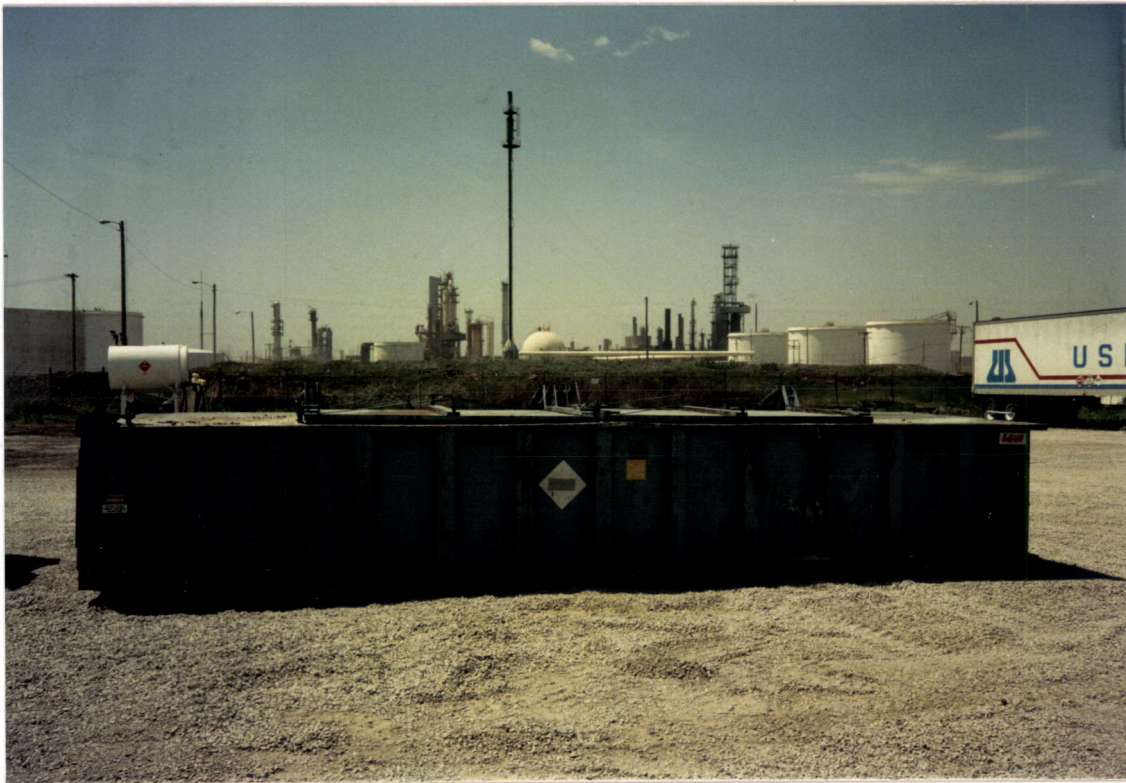
Film Roll No.: 2 Date: 6/19/90 Time: 1135
 Exposure No.: 4 Photographer: JPN
 VSI Observations: USPCI gondola for holding (accumulating) dry solids
wastes (non-land-banned wastes) with vehicle fueling in left background.
 View - S

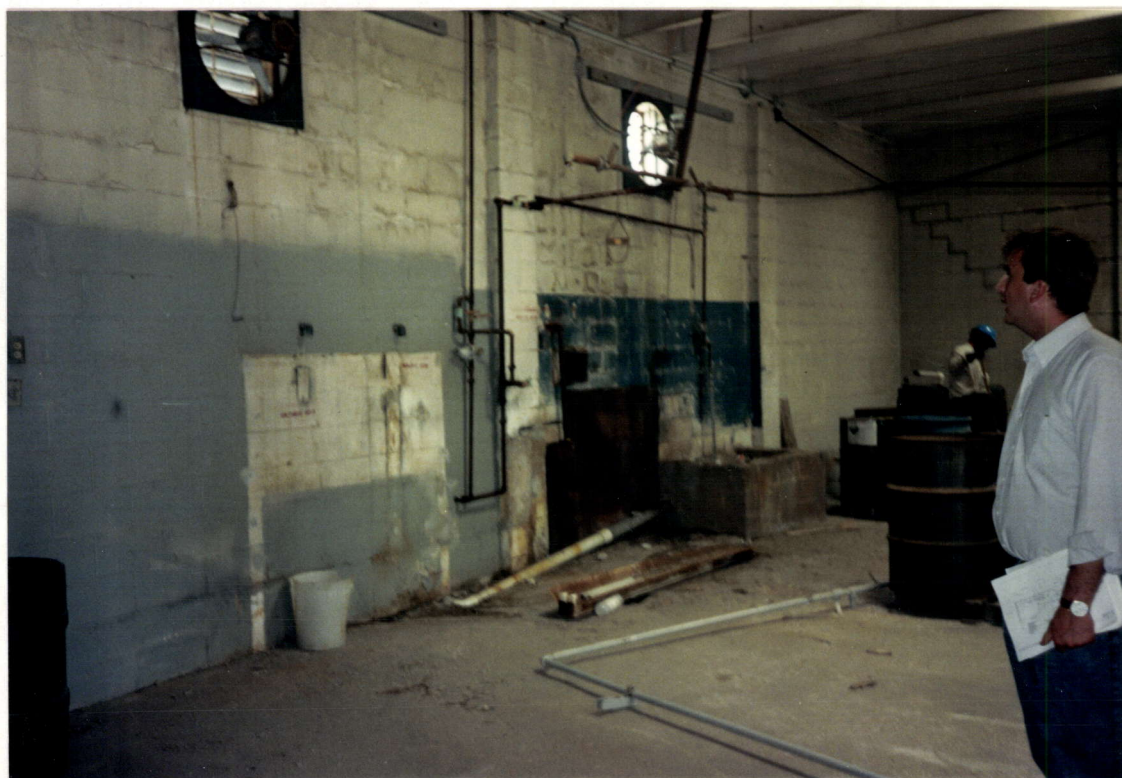
Film Roll No.: 2 Date: 6/19/90 Time: 1330
 Exposure No.: 9 Photographer: JPN
 VSI Observations: Out-of-service acid repackaging area for Service
Chemical Supply Co., Building 17. View - NE

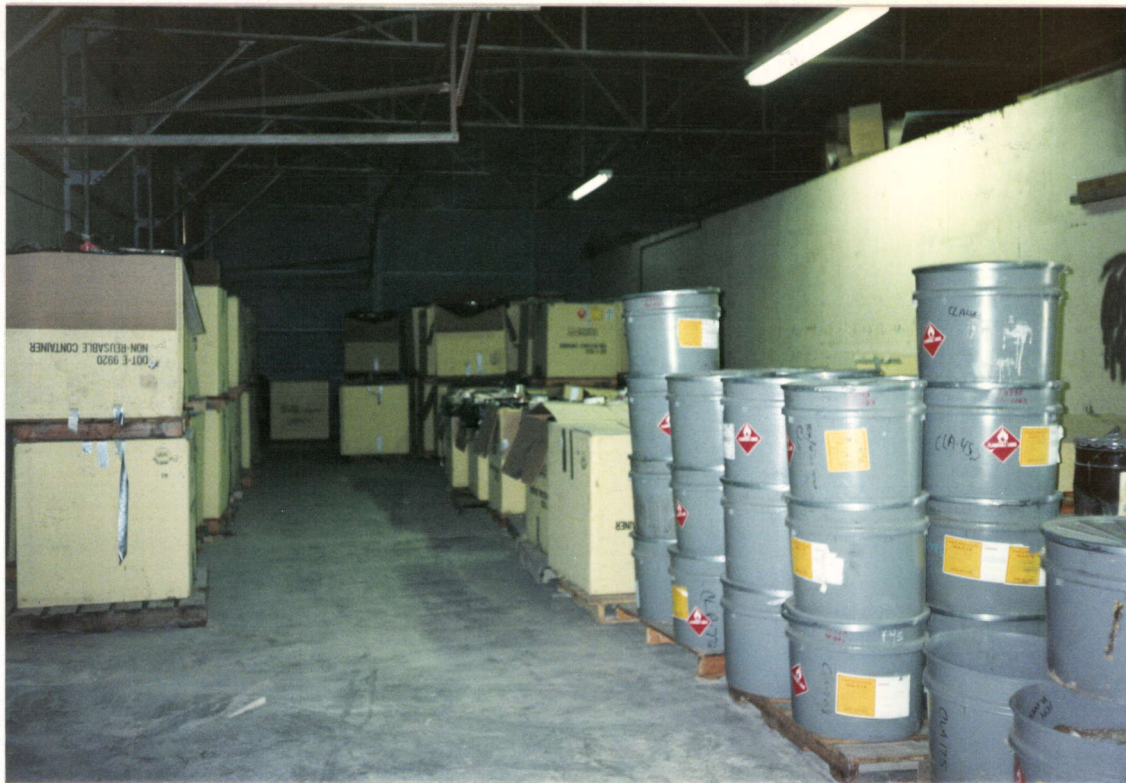
Film Roll No.: 2 Date: 6/19/90 Time: 1345
 Exposure No.: 10 Photographer: JPN
 VSI Observations: Household waste collection containers and empty
containers in Bldg. 18. View - E

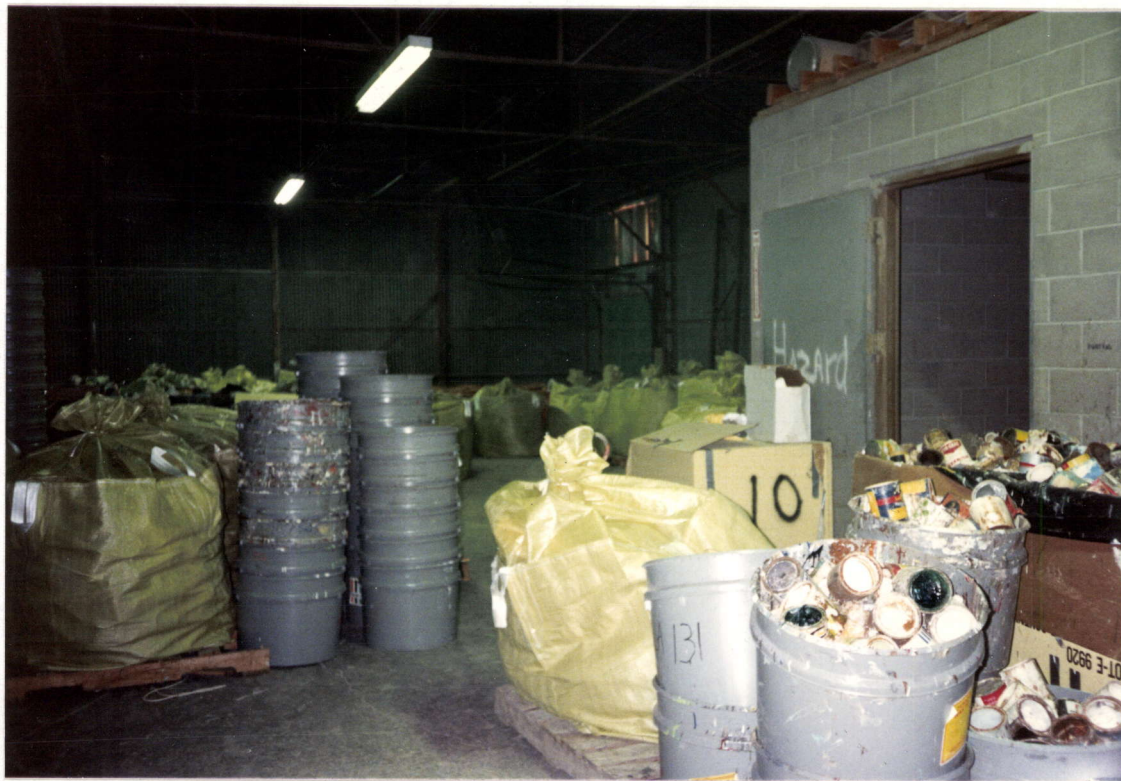
Film Roll No.: 2 Date: 6/19/90 Time: 1350
 Exposure No.: 11 Photographer: JPN
 VSI Observations: Household waste collection, 55-gallon lab packed drums
and bagged containers. View - W

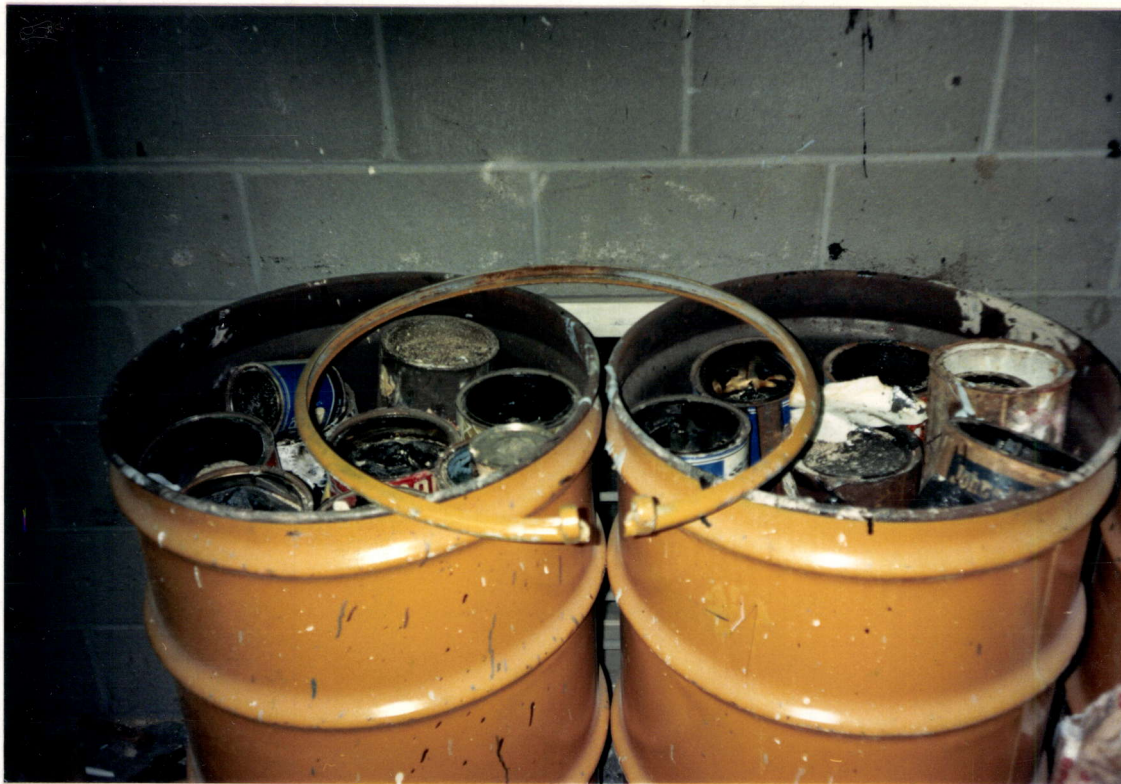
Film Roll No.: 2 Date: 6/19/90 Time: 1350
 Exposure No.: 12 Photographer: JPN
 VSI Observations: Open 55-gallon drums containing household waste
collection empty containers. View - N

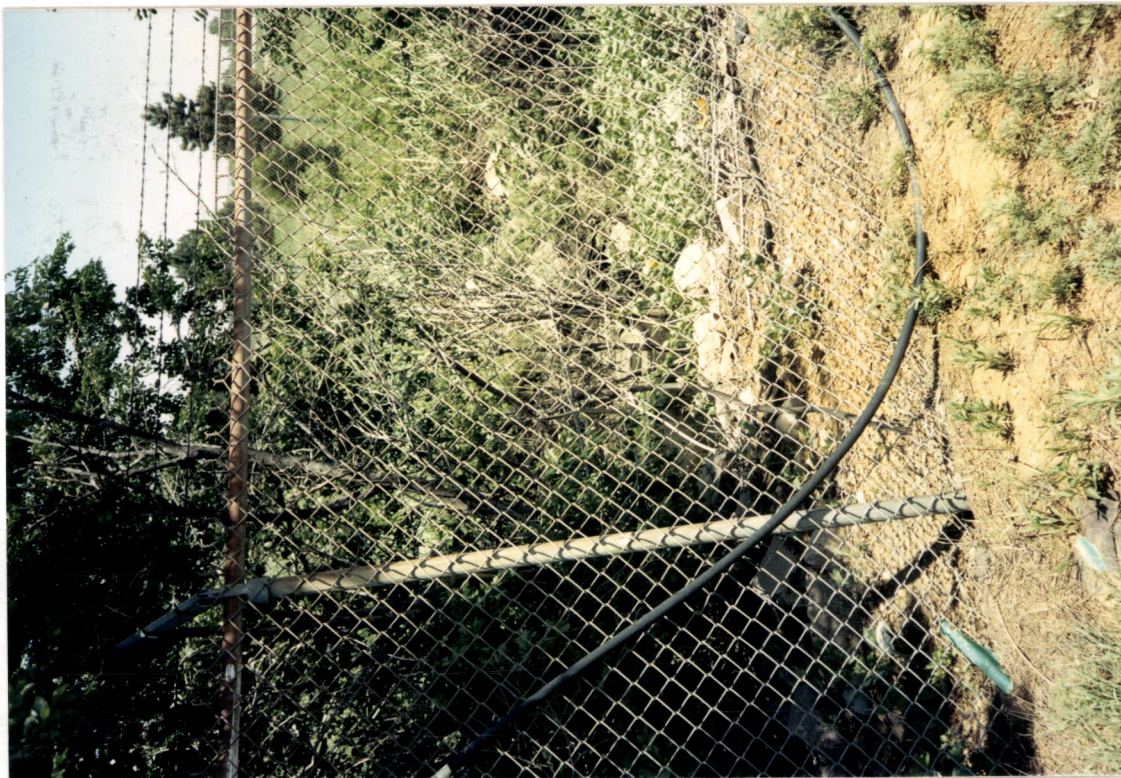
Film Roll No.: 2 Date: 6/19/90 Time: 1410
 Exposure No.: 13 Photographer: JPN
 VSI Observations: Drainageway between Service Chemical Supply Co. property
and Union Pacific RR property. (Note surface staining in foreground).
View - N

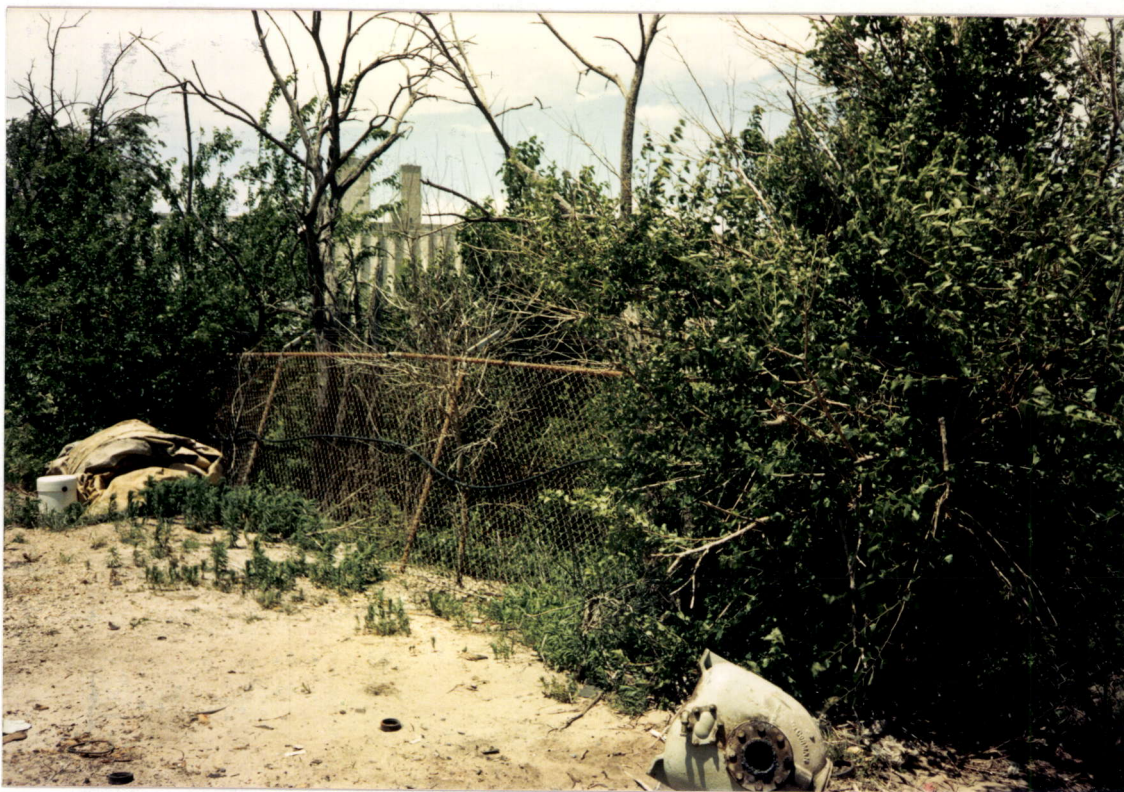
Film Roll No.: 2 Date: 6/19/90 Time: 1415
 Exposure No.: 16 Photographer: JPN
 VSI Observation: Fence line between SCSC property and drainageway. View
- NW to N

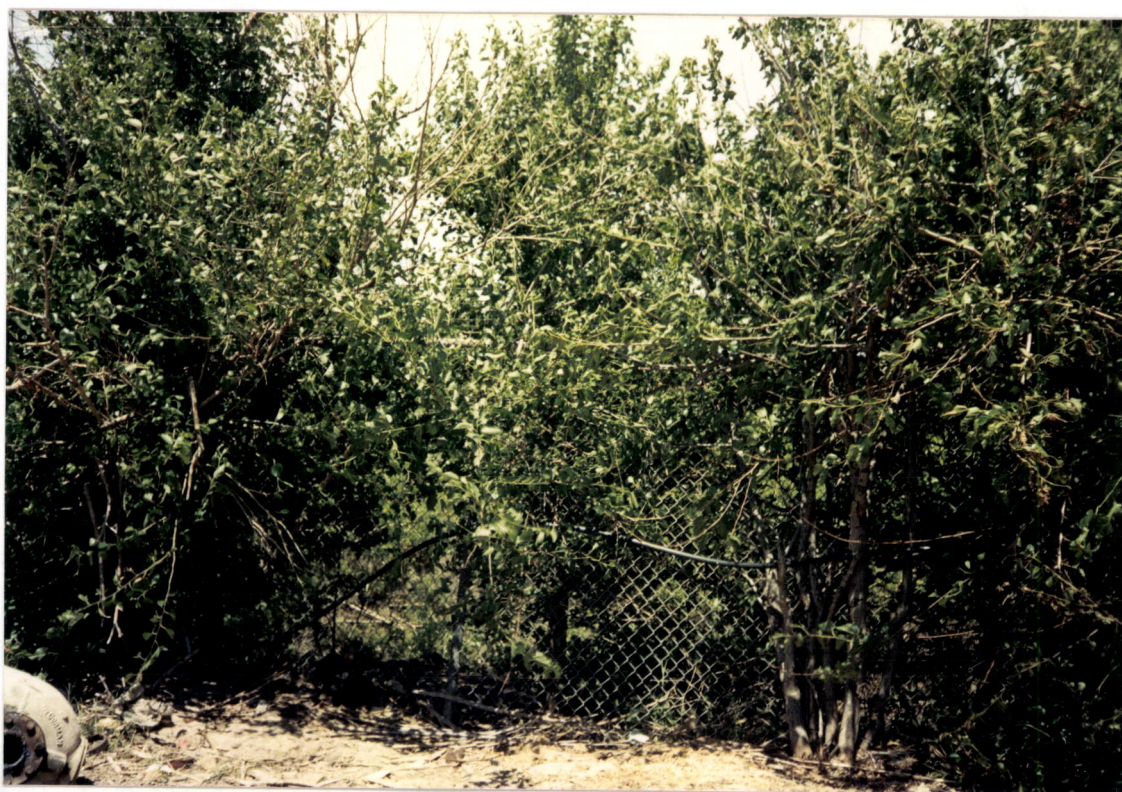
Film Roll No.: 2 Date: 6/19/90 Time: 1415
 Exposure No.: 17 Photographer: JPN
 VSI Observation: Fence line between SCS and drainage way. View - NW to N
